# TOB Modules with ST Silicon: Experience and Results from Recent Studies

*Joe Incandela*

*For the US CMS Tracker Group*

*ST Workshop, CERN, Dec. 1, 2003*

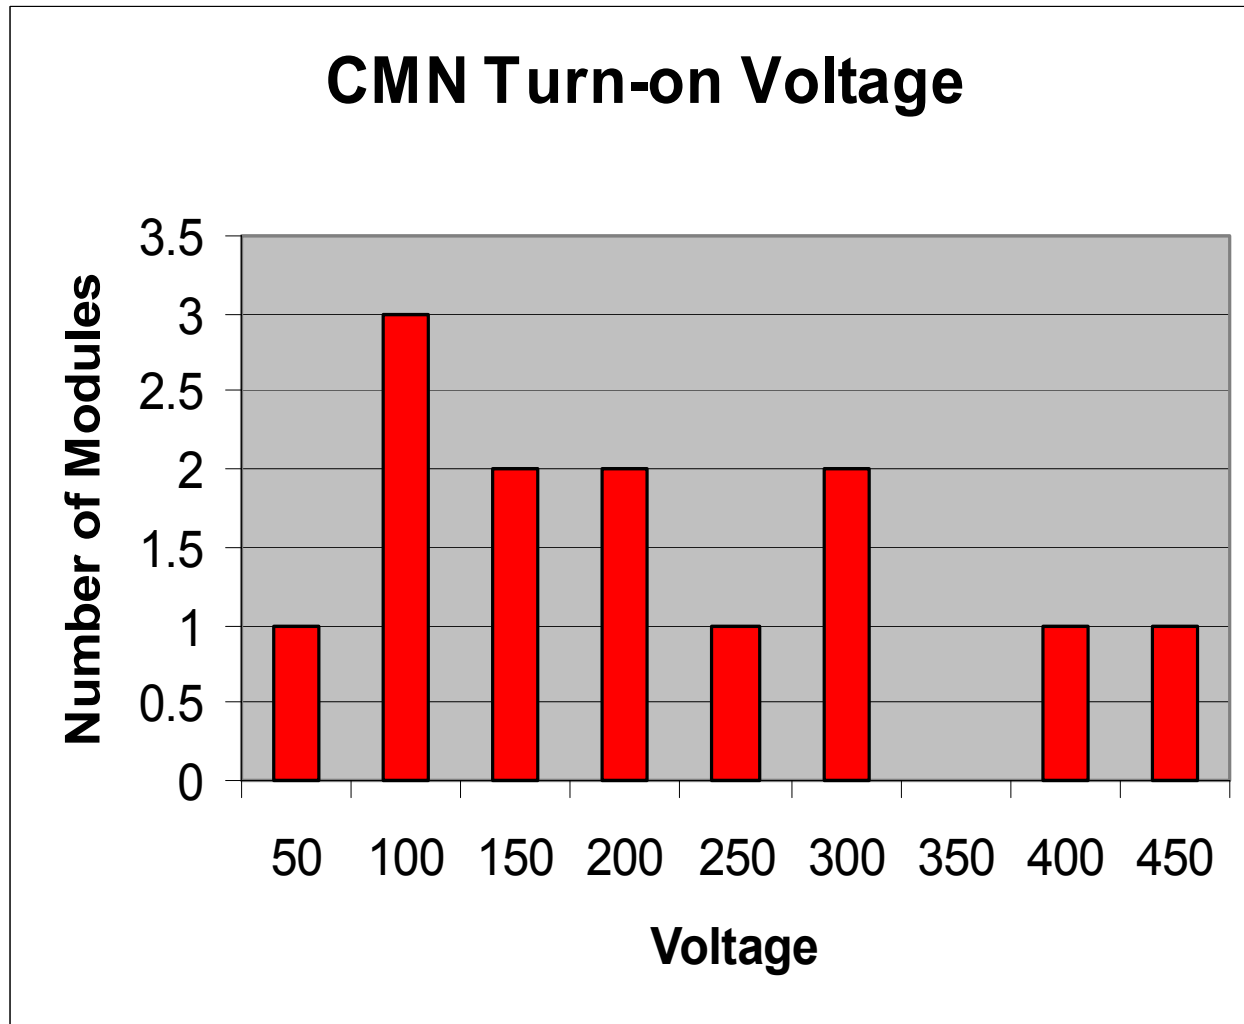
# CMN Turn-on Voltage

- 14 of 60\* modules produced at UCSB exhibit large common mode noise (one chip only)
- Correlated w/increase in bias current w.r.t. QTC probing
  - Initially, increased current was noted after module assembly. There was some concern that it was caused by assembly or bonding.
  - Later, the increased current was seen in measurements made on wafers before assembly, thereby ruling out the hypothesis that it might be due to the assembly process.
- Characterized by high noise on 1-4 channels
  - Current is in fact localized to these channels
  - No obvious associated damage in visual inspection
- At UCSB the problem always appeared by the first module test
  - 1 module at FNAL developed problem during Wien box LT testing after a full ARCS module characterization

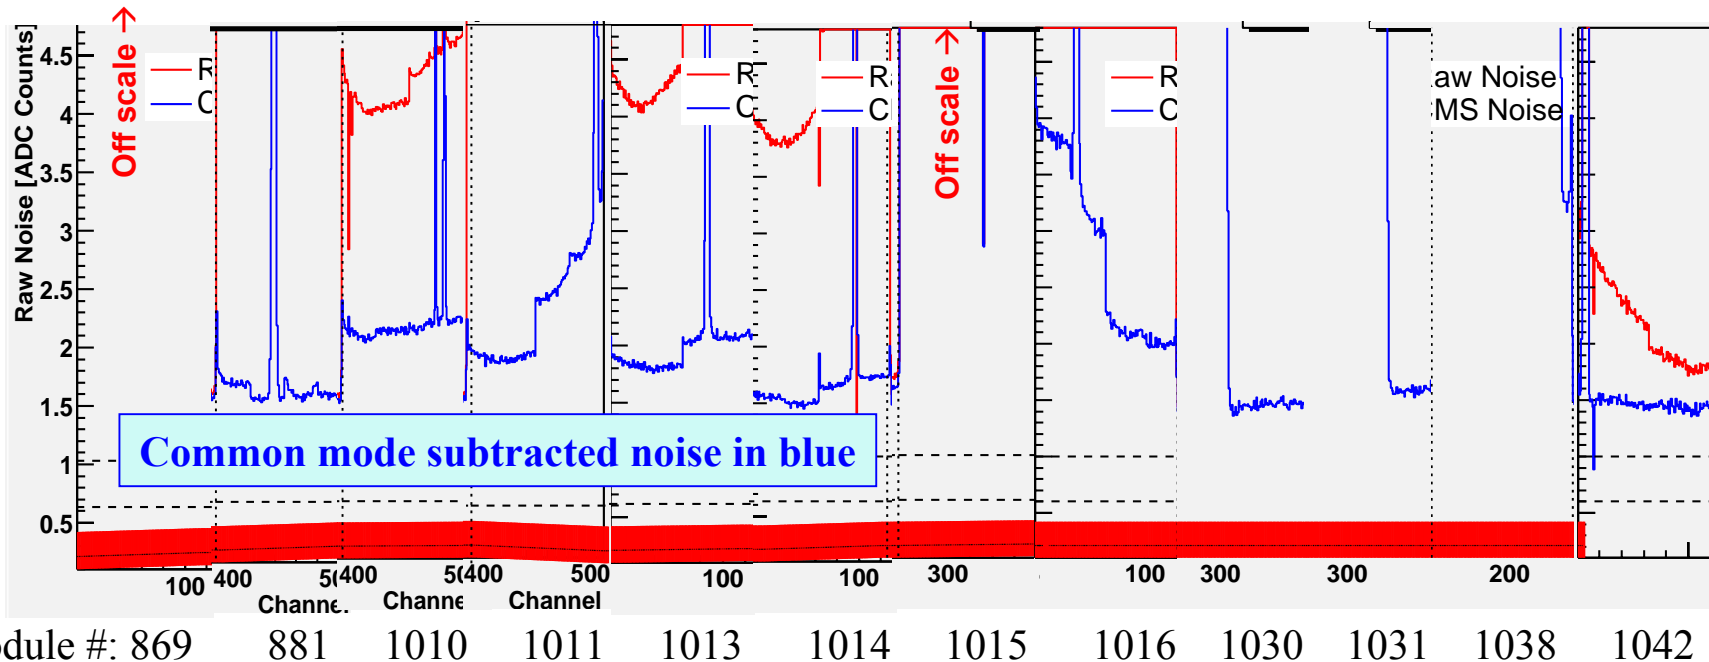
# Common Mode Subtracted Noise

Montage of chips with CMN on 12 separate modules

For majority of modules with problems, the CM subtraction is imperfect. After common mode subtraction, many still have significantly elevated noise.

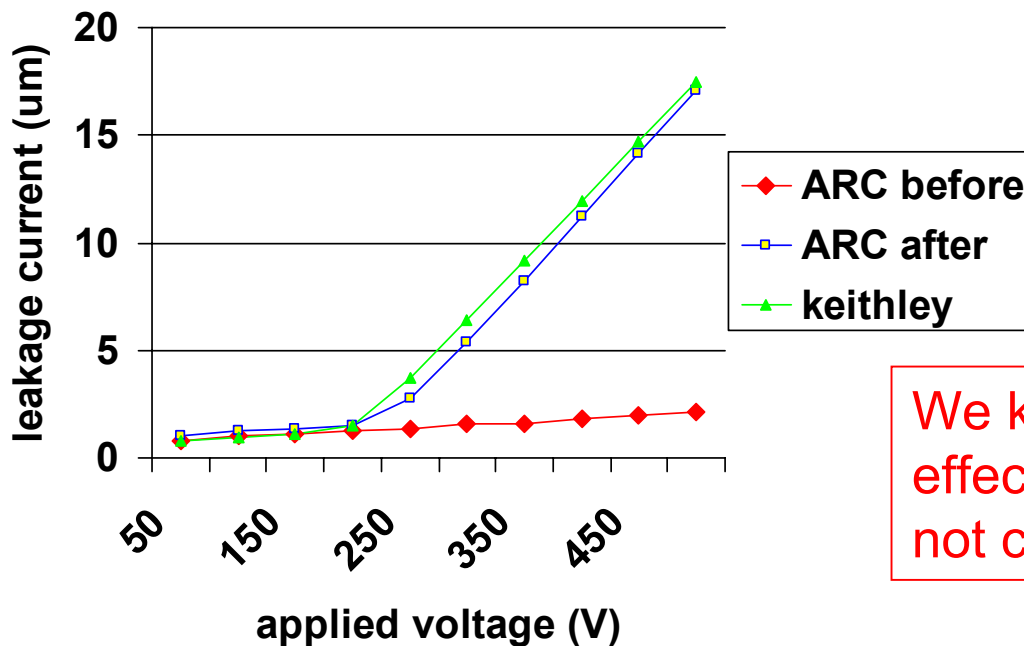
# FNAL Module Spontaneously Develops CMN

- "before" measurement is taken on 09/08 on ARCS before LT
- "after" measurement is taken on 09/23 on ARCS after LT
- green curve is a measurement done using Keithley on 09/24 with 1 minute interval between steps

No visual defects are observed on the sensors around noisy channel #219

We know it is not a humidity effect: 3 weeks in dry air did not cure it

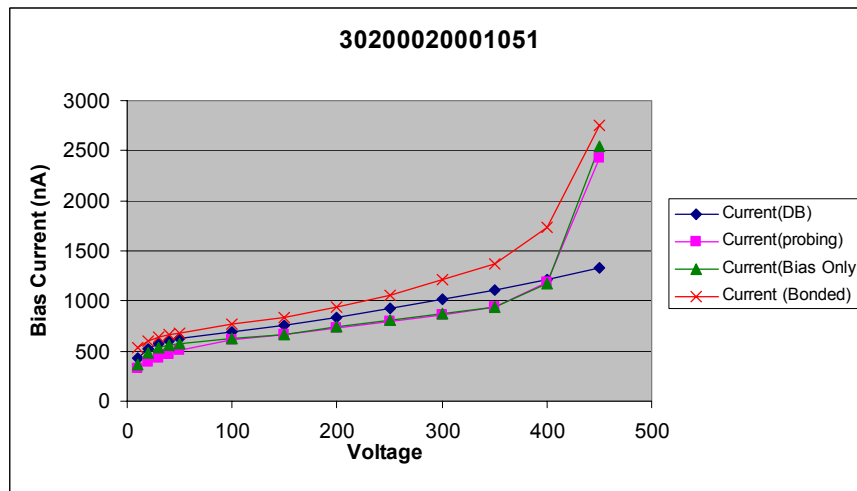
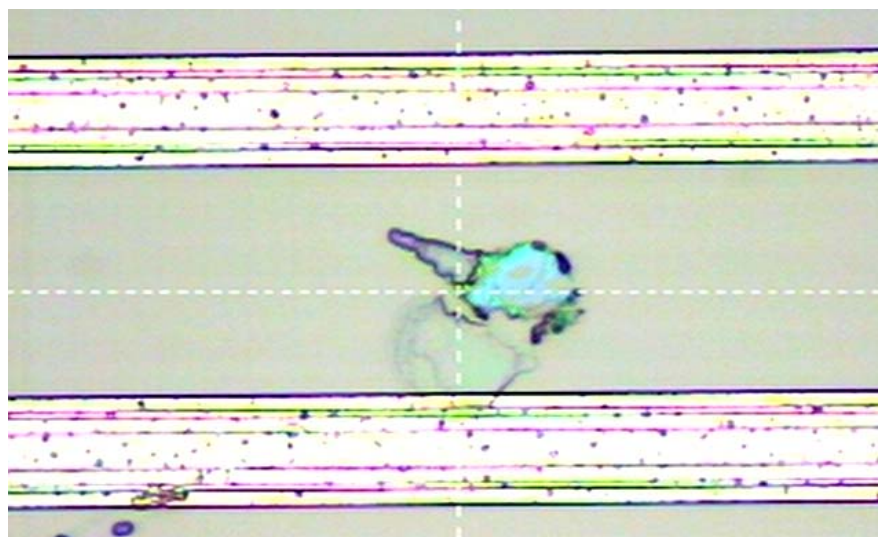
# New CMN Problem Module (1051)

- Last SS6 module built using one sensor with 1.2  $\mu\text{A}$  extra current (1700 nA vs 50 nA) in UCSB re-probing at 450 V.
  - Well within old selection criteria
  - No significant increase of current during module assembly
  - Uses somewhat older sensors
    - 30210320274206
    - 30210320274214
- CMN seen in chip 46 with extremely high noise in channels 423-424
  - Sensor flaw seen between two channels – not known if relevant.
  - Begins at 400 V where measured current diverges from database  
~0.5  $\mu\text{A}$  difference

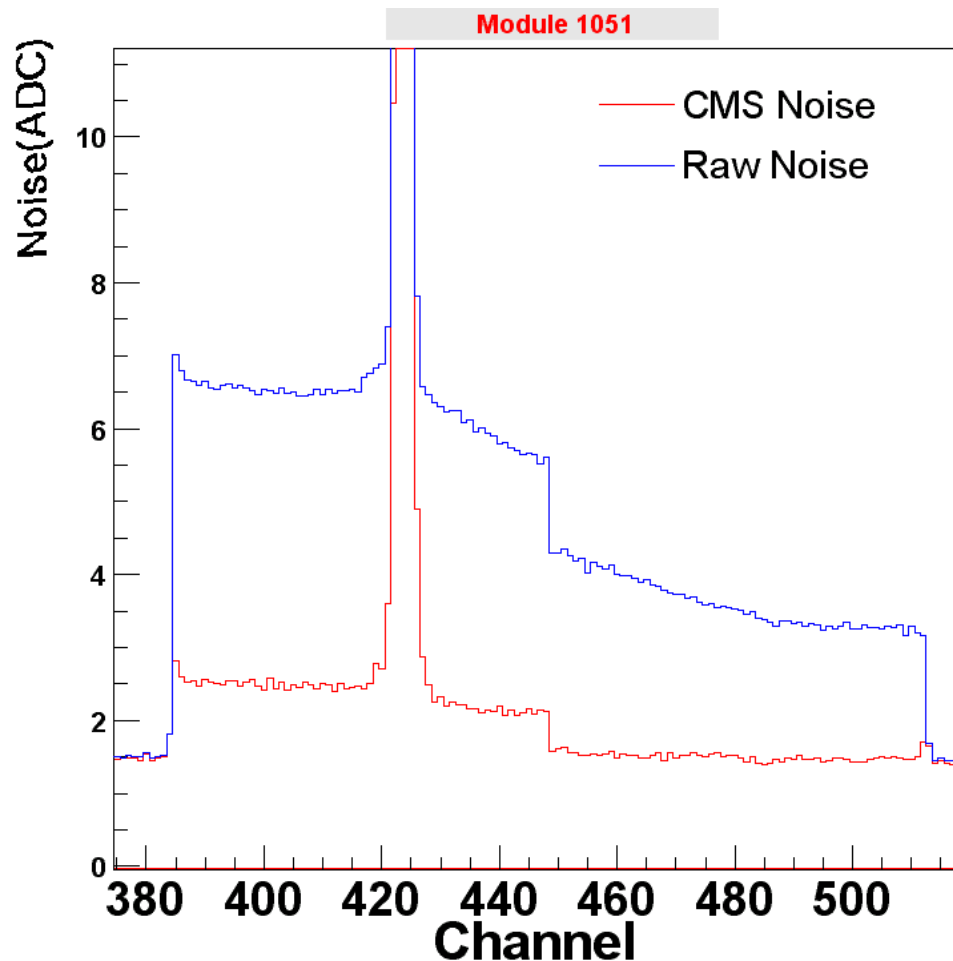
# CM Noise on Module 1051

- Module tested at slightly elevated voltage
  - Bias current  $3.7 \mu\text{A}$ ,  $< 2 \mu\text{A}$  more than expected from database
- First half of chip has CM subtracted noise a factor of  $\sim 1.75$  higher than typical.
  - A very little amount of micro-discharge can cause the CM subtraction algorithm not to work properly
    - CM subtraction algorithm used is same as LT, and test beam software

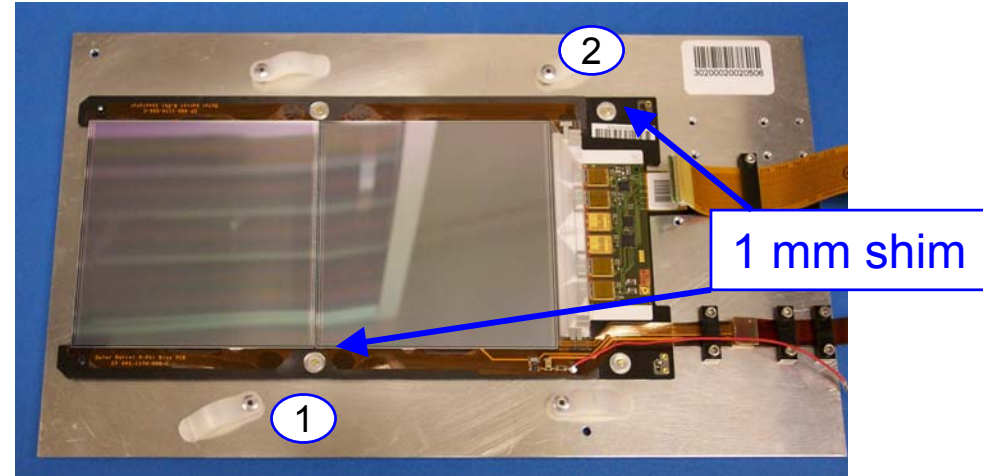
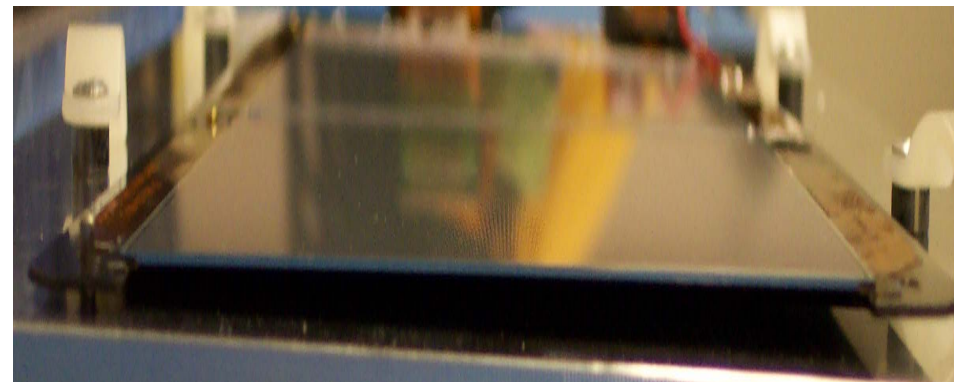
# Mounting on cold plate

- Modules attached to cold plate with 4 screws through thermal contacts
- To test the effects of twisting modules, 1 mm shims added under thermal contacts
  - Bias current measured with 1 or 2 shims for all 10 modules
    - No observed change in current

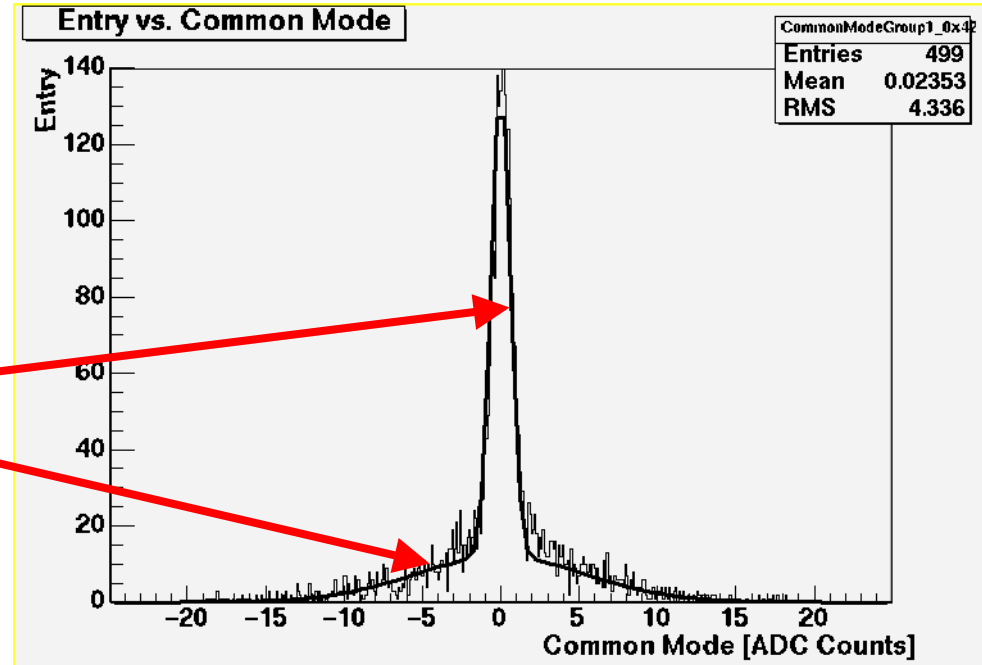
# Study of CMN Spectra

- The common mode point is calculated event-by-event for groupings of 32 channels
  - The spectra of the common mode is fit for the groupings within a chip with CMN problems - excluding the grouping with the high noise channel
- Spectra is fit with two Gaussians
  - Central core  $\oplus$  tail
  - Fit parameters are:
    - Fraction of events in tail
    - Width of central core
    - Width of tail
- Study variation of parameters with bias current by increasing bias voltage in steps of 50 V

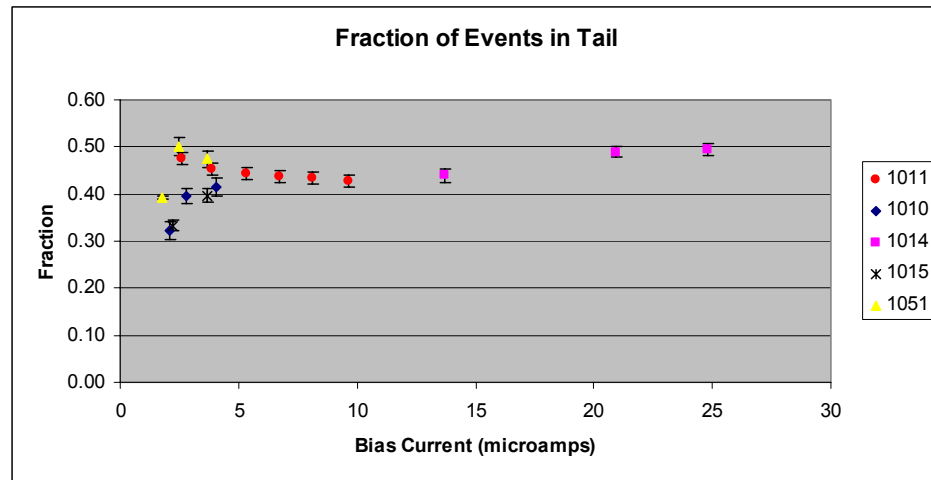
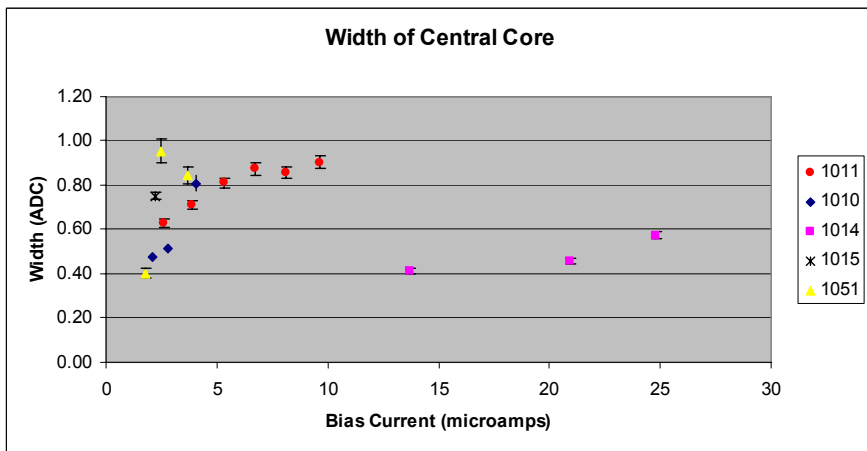
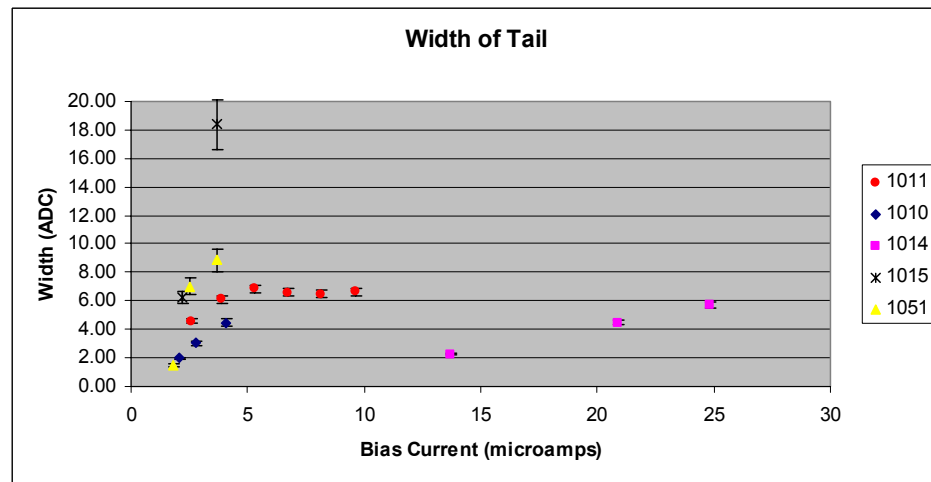
# Fit Result of Common Mode Point

- Fraction of events in tail is relatively flat with bias current (~strip current)
- Width of central core increases with bias current (~strip current)
- Width of tail also increases with bias current (~strip current) and may flatten out at some current
