US Production Report

CMS Tracker Steering Committee
4 September 2003

J. Incandela
University of California
Santa Barbara

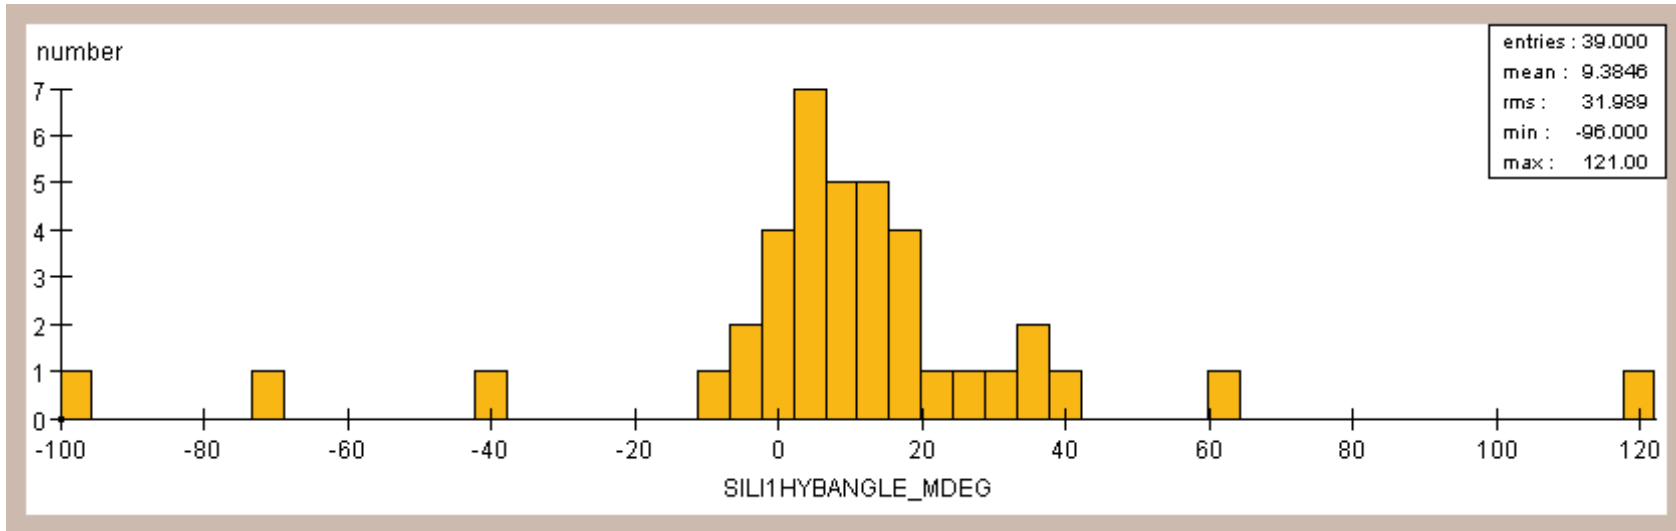
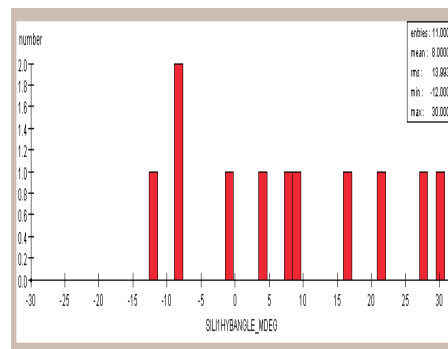
Gantry Results (UCSB) - 2

By slightly increasing the hybrid clamping we reduced the angular range of silicon-to-hybrid alignment by more than a factor of 5 (240 mdeg to 45 mdeg)

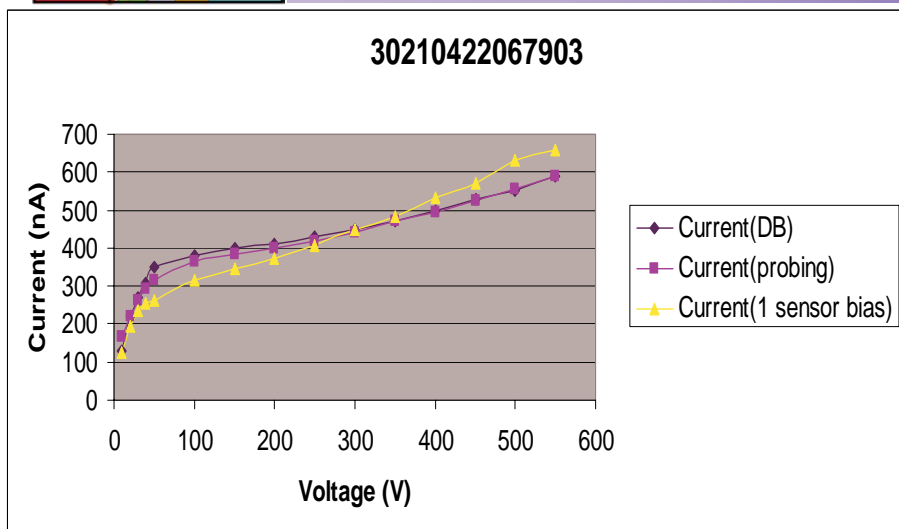
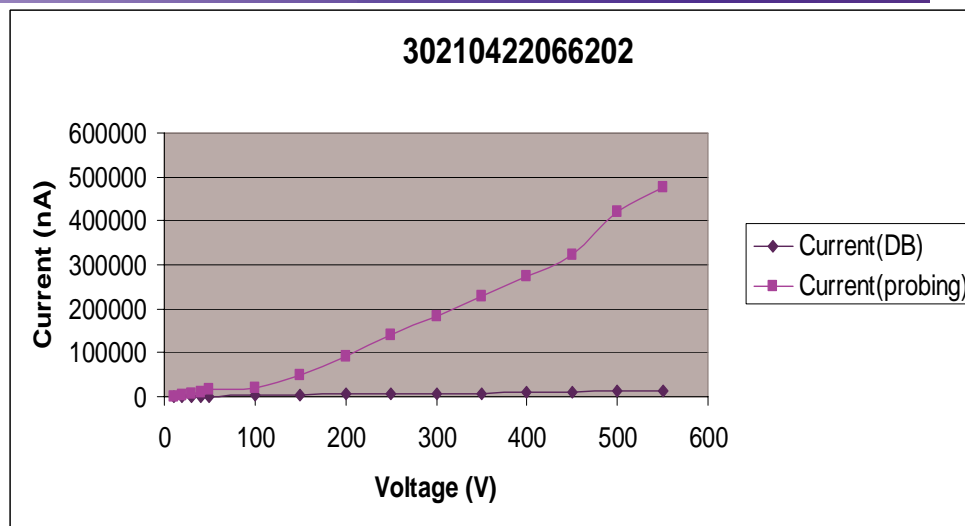
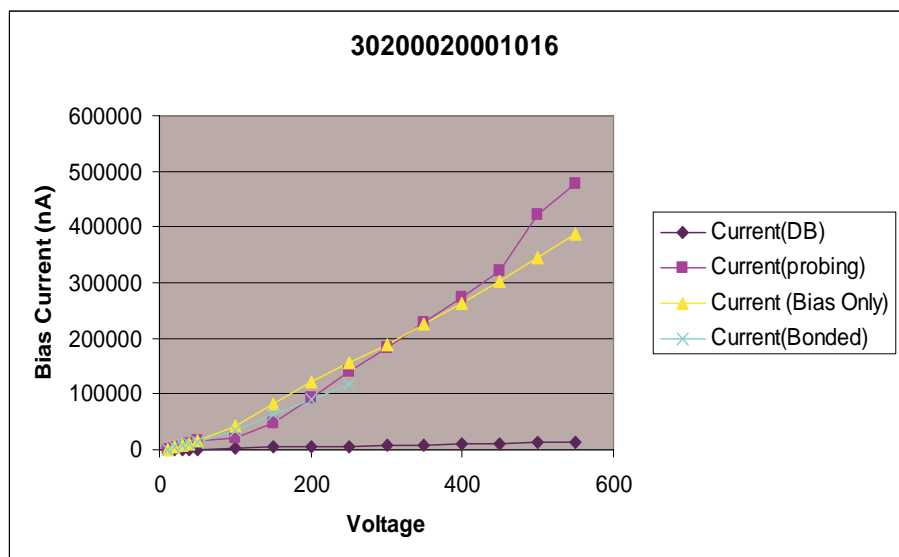
30200020001016

Mid-sensor open burn seen in sensor 30210422067903, channel 285.

CMN problem seen in chip 1 channel 38 due to sensor 30210422066202. CMN Noise problem begins at 90 V

Note: the channels referenced above were found to be the noisy channels resulting in the high current found in IV probing.

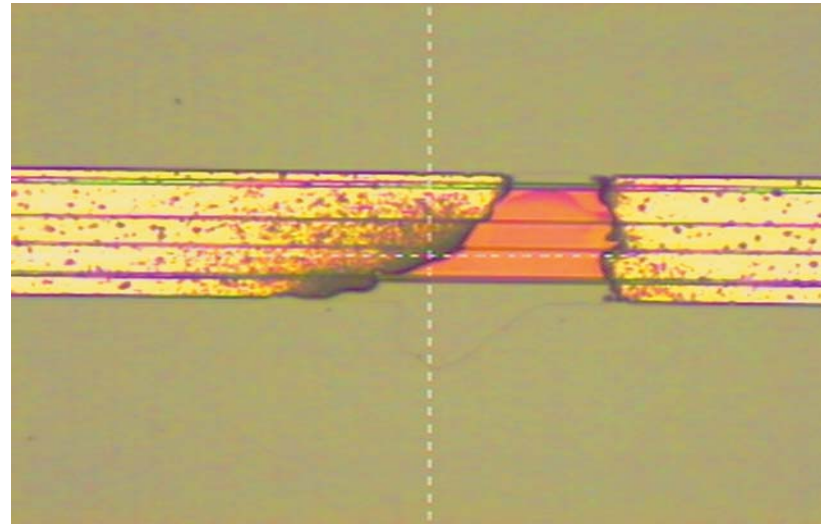
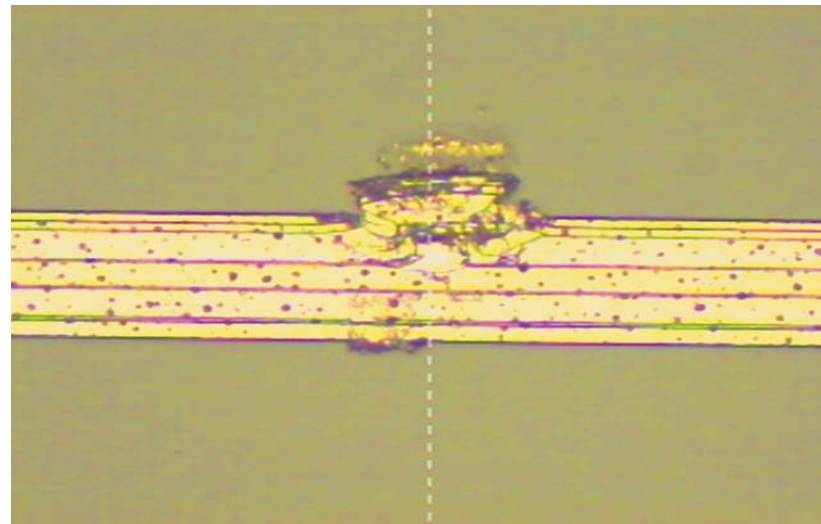
Pictures of 30200020001016

- Picture of mid-sensor open “burn” seen in sensor 30210422067903, channel 285.
- Picture of channel 38, sensor 30210422066202. CMN noise problem begins at 90 V

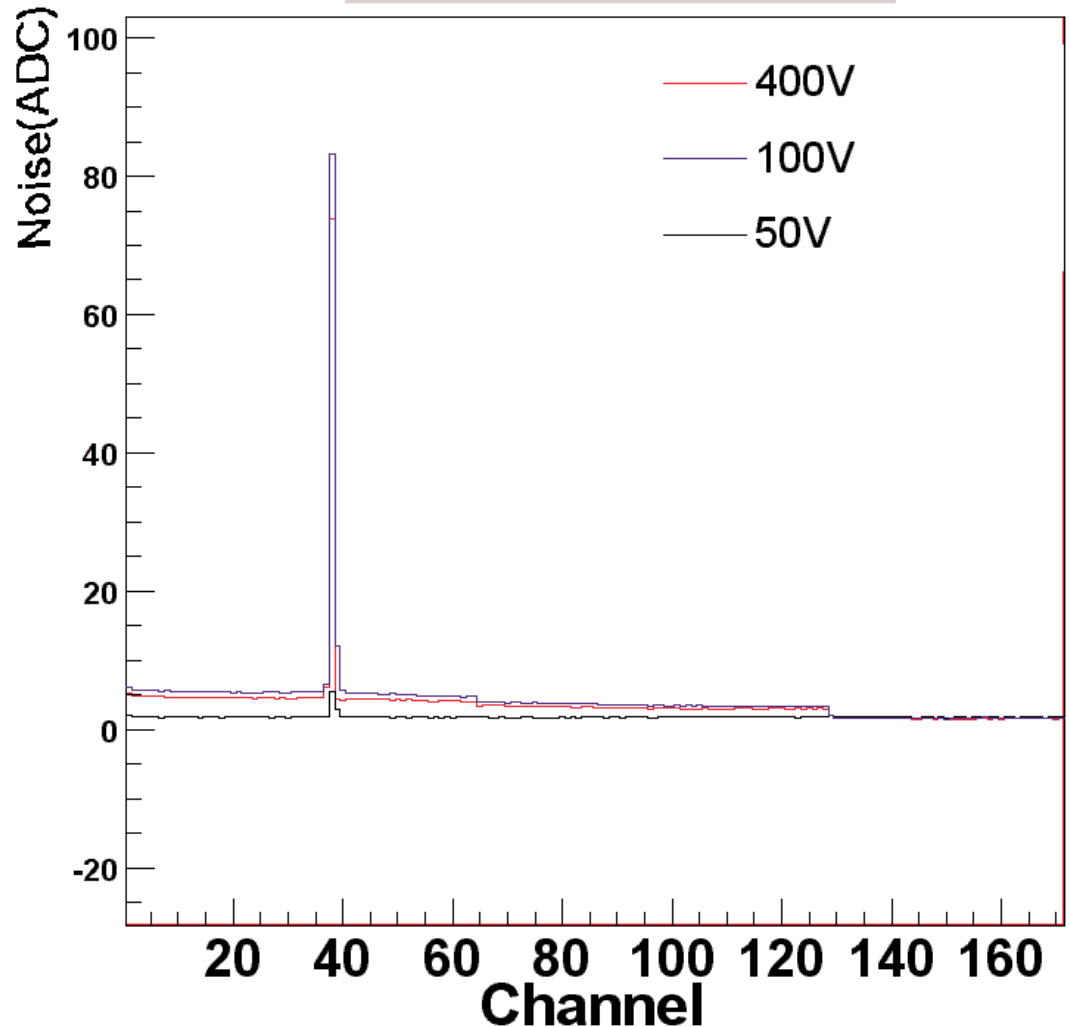
Module 1016

- Noise starts increasing on channel 38 with 10 V bias
 - Assume micro-discharge
- Noise on channel 38 reaches a plateau at 100 V bias and is large enough to cause 5 ADC common mode noise on chip 1.

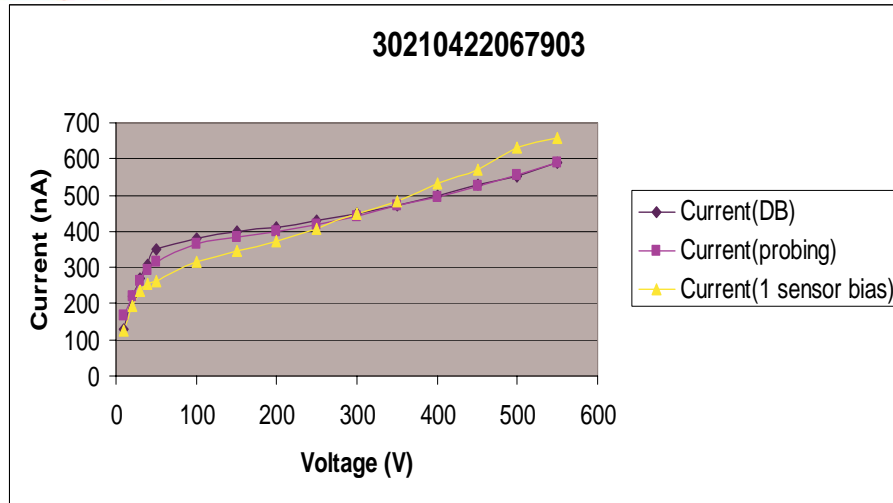
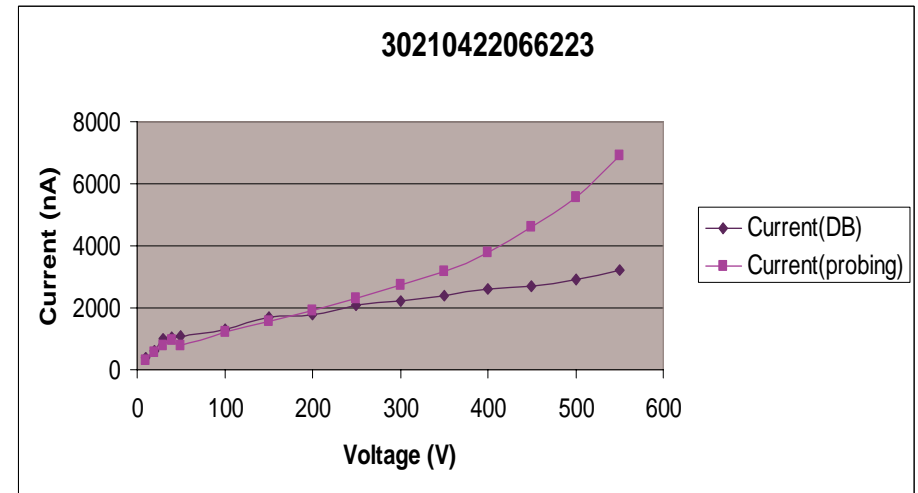
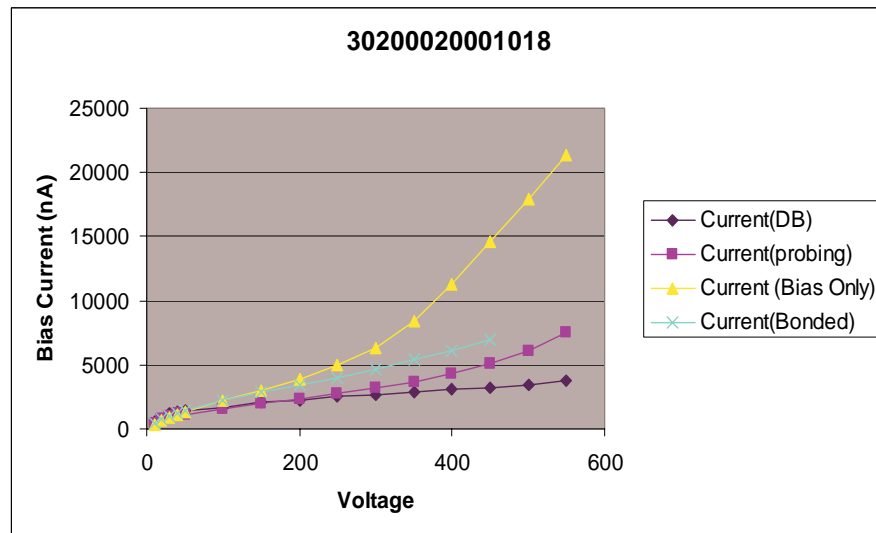
30200020001018

Mid-sensor open burn seen in sensor 30210422066223, channel 446. This may explain the increased current seen in UCSB IV probe and the decrease after module bonding.

Channel has about half the average LED response.

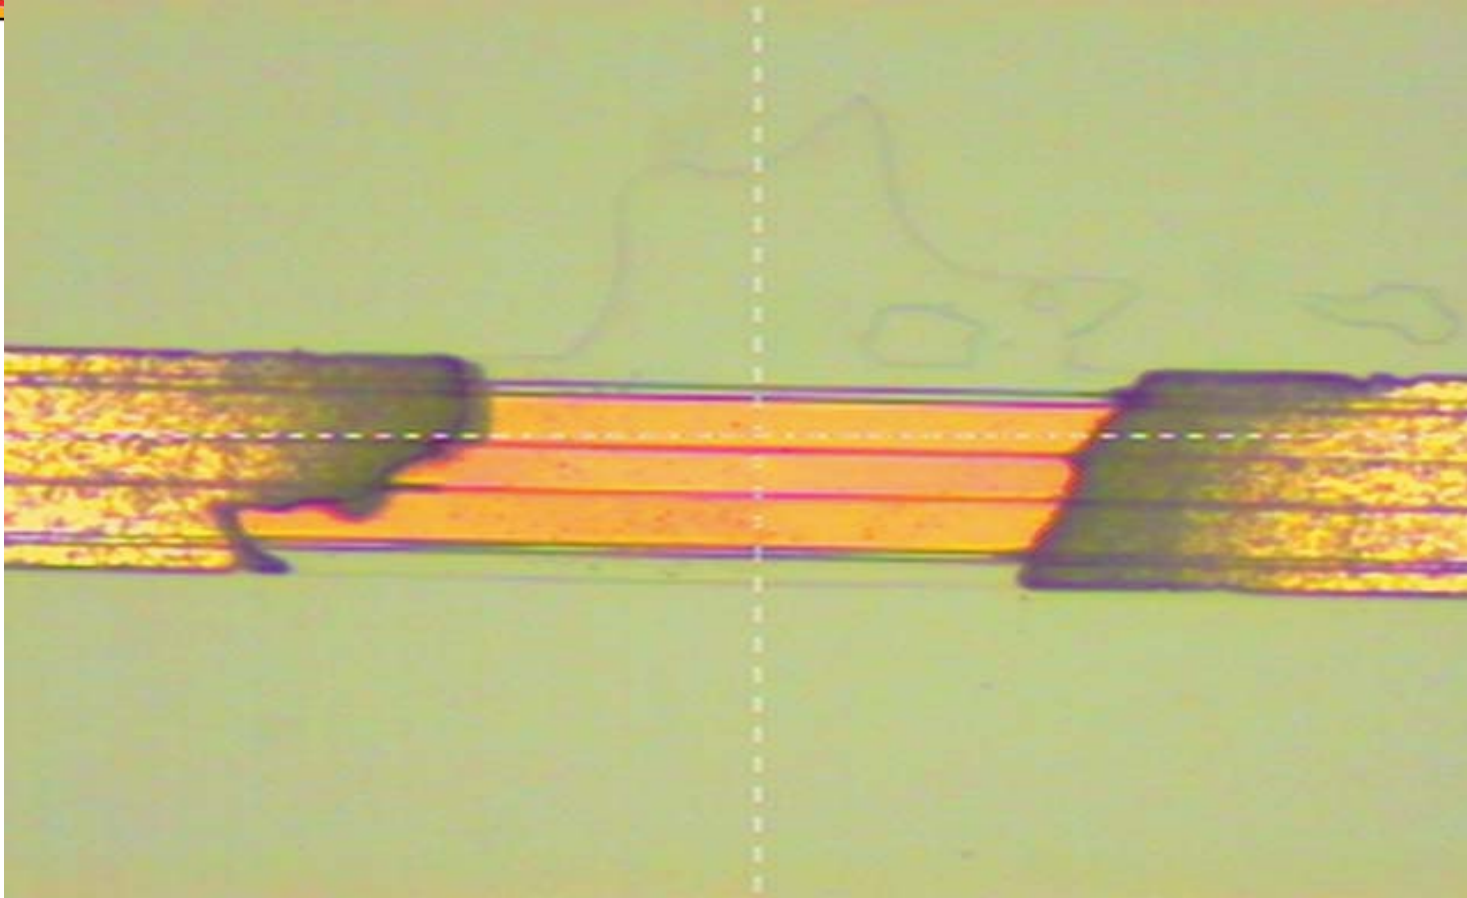
Picture of 30200020001018

Sensor mid-sensor open due to “burn” on
channel 446, sensor 30210422066223

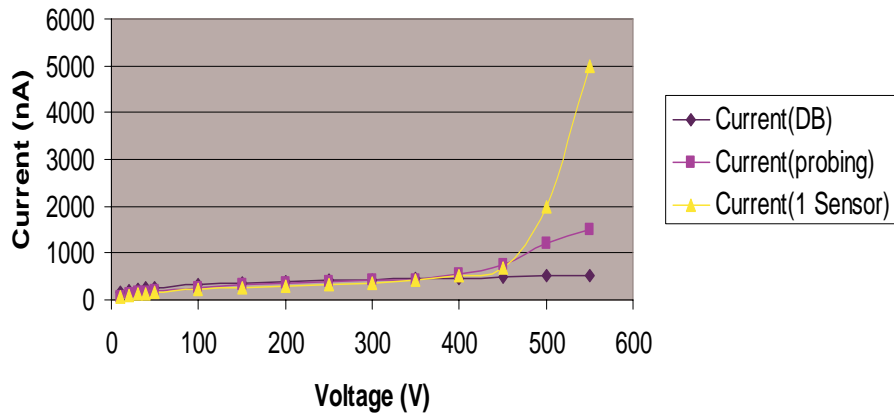
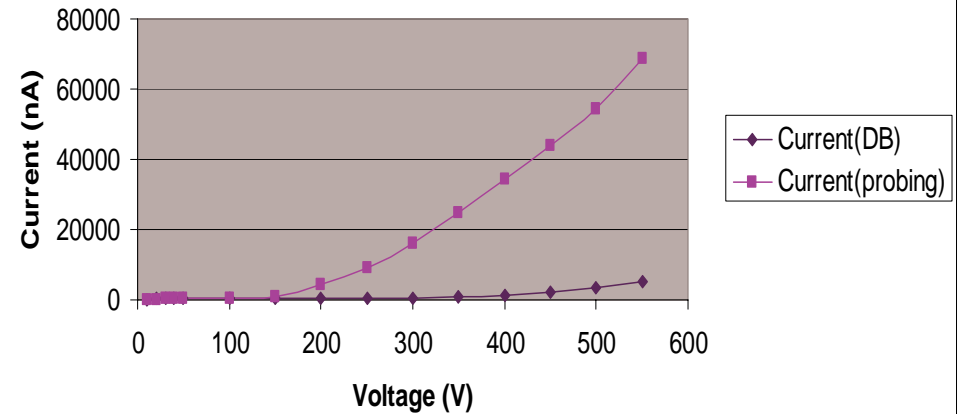
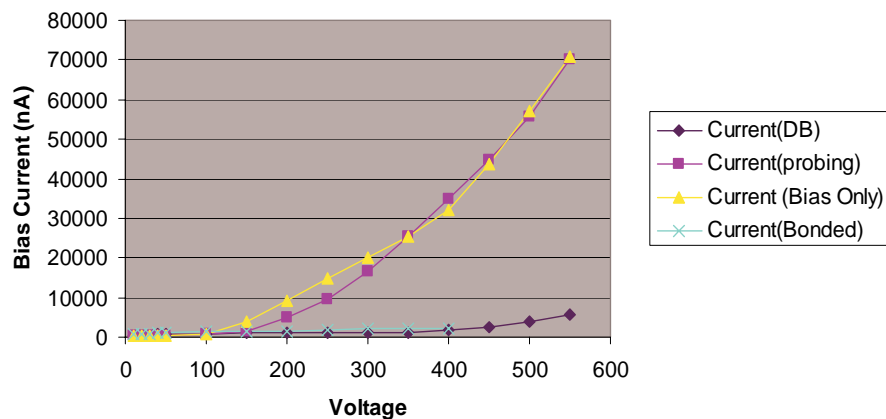
30200020001030

Sensor scratched due probing of hybrid.
Bias and guard rings damaged but this
results in LOWER current!

Upon initial power-up, the bias current is
high and CMN problem seen in chip 3,
due to channel 308 in sensor
30210420383228. As running persists,
noise decreases and CMN problem stops!

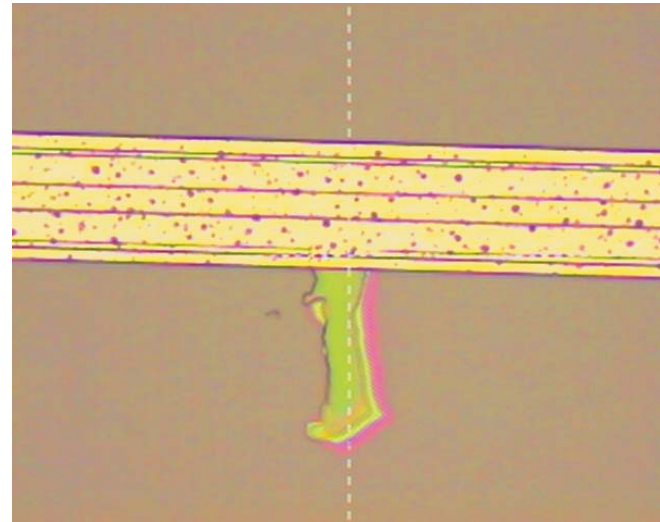
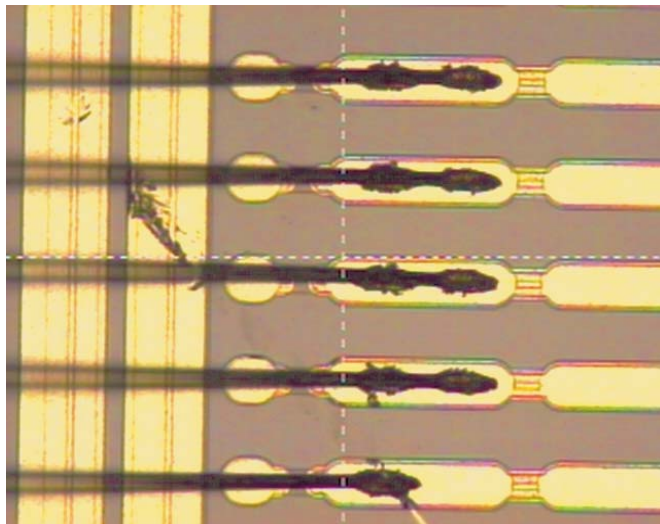
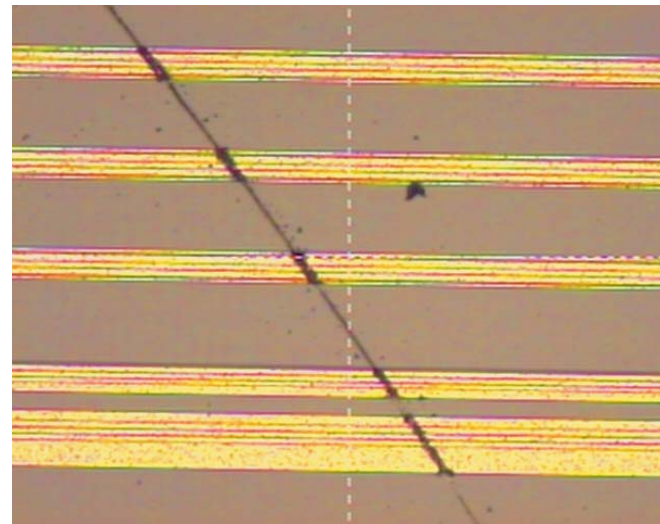
Pictures of 30200020001030

- Picture of channel 308, sensor 30210420383228 which causes CMN problem on chip 3.
- Accidentally scratched sensor while probing a hybrid problem.

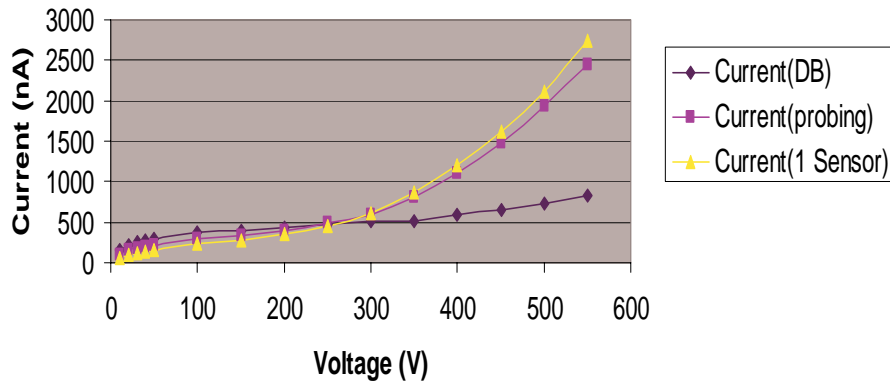
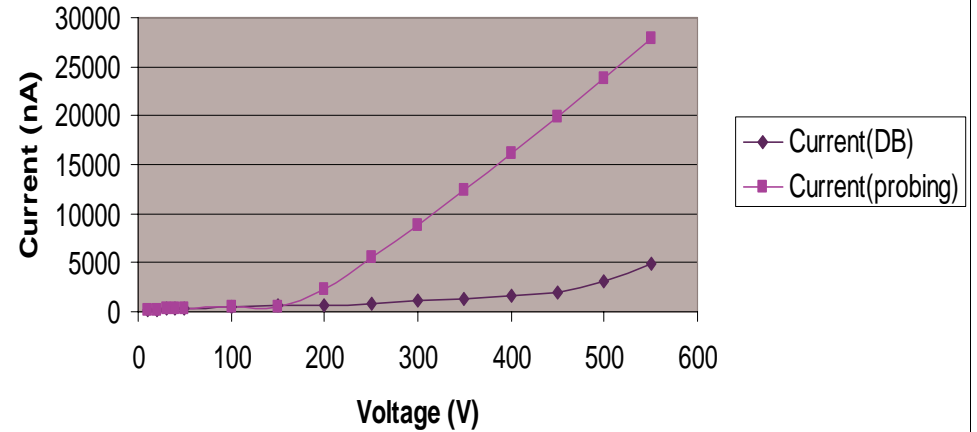
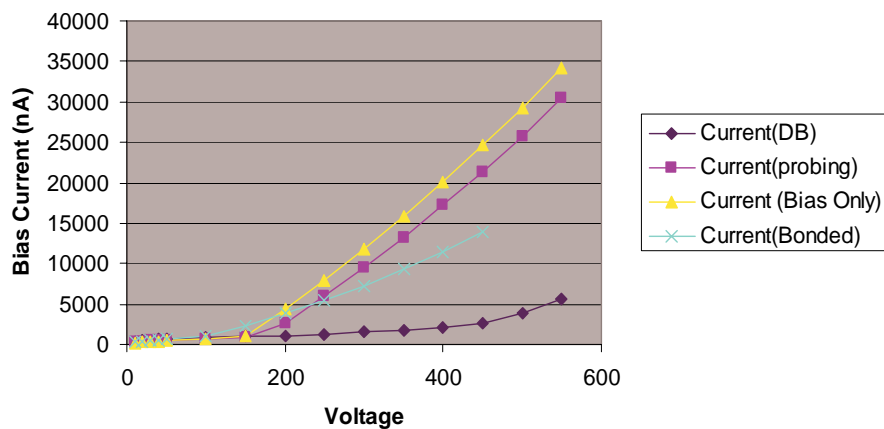
30200020001031

CMN problem seen in chip 3, due to channel 336 of sensor 30210422066202. Noise is a maximum at 240 V, and then *decreases* at higher bias voltage below the threshold level required to cause a serious CMN problem.

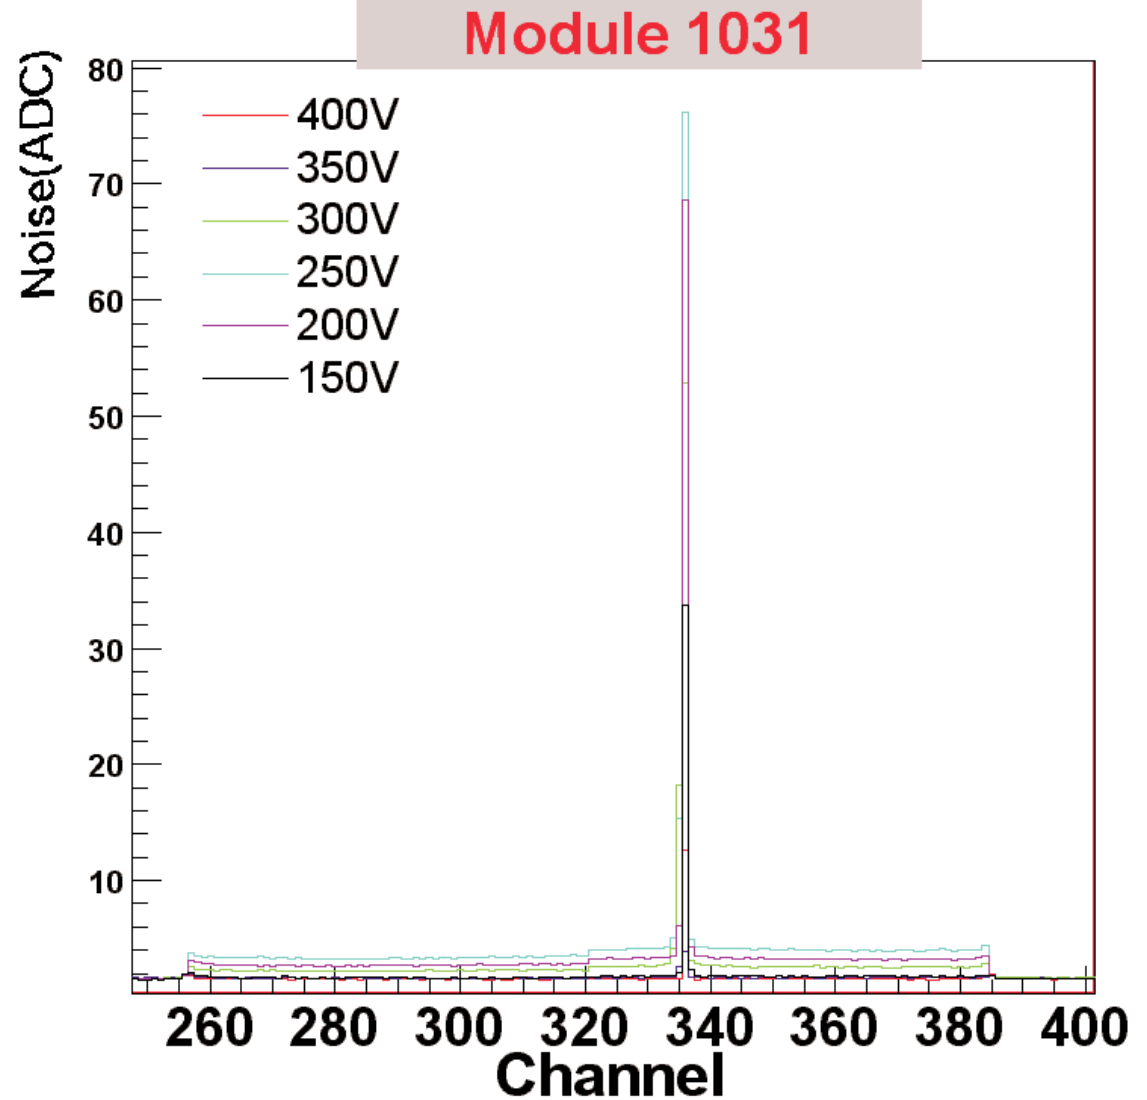
Noise of 30200020001031

- Channel 336 shows initially increasing noise with voltage
- CMN on chip 3 reaches maximum at 250 V.
- CMN decreases as voltage increase beyond 250 V.
- At 400 V, CMN is gone. Noise on channel 336 is only 12 ADC counts.

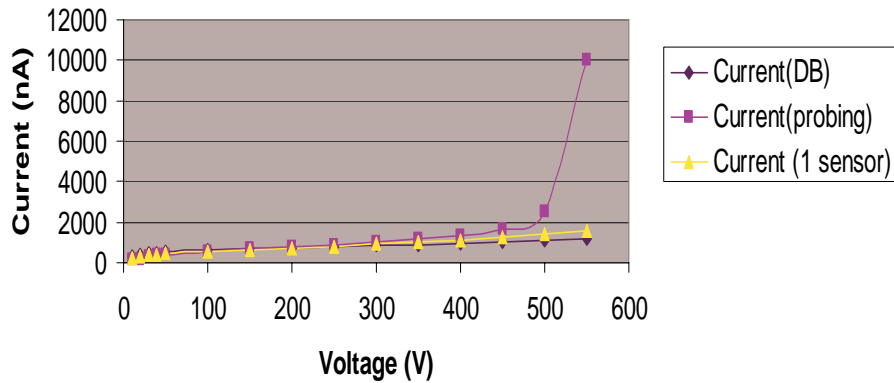
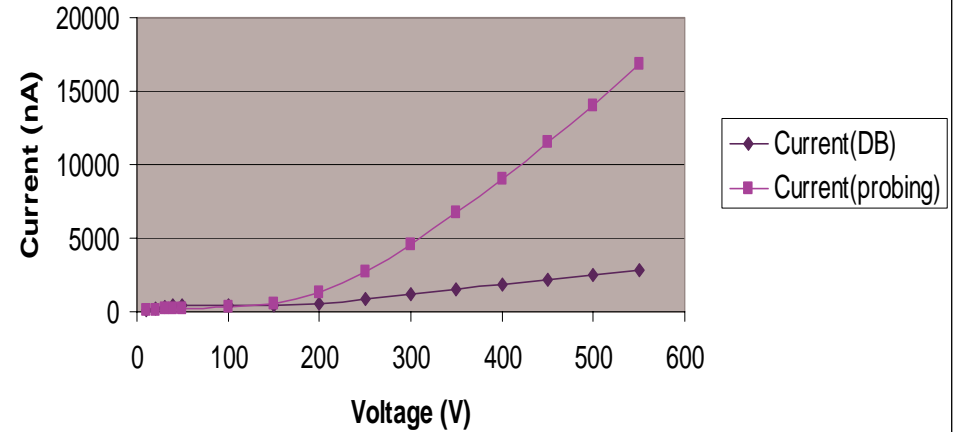
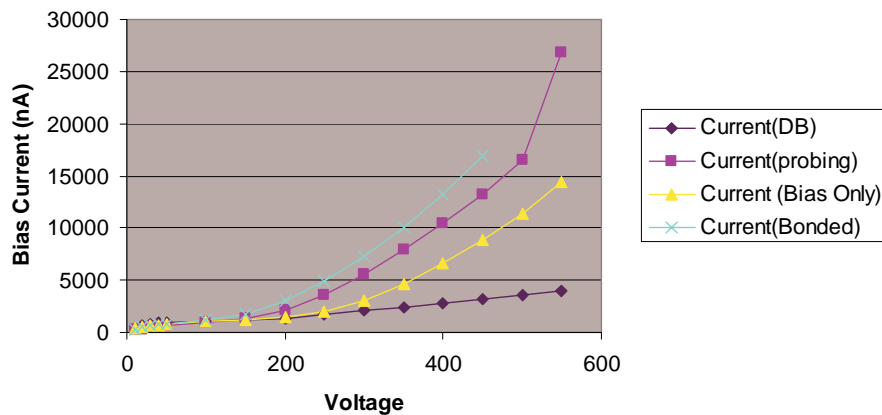
30200020001042

Micro-discharge problem seen in chip 1, channel 7-10 of sensor 302104845823. CMN on chip 1 starts at 450V but increased noise is seen at lower bias voltages on channels 7-10

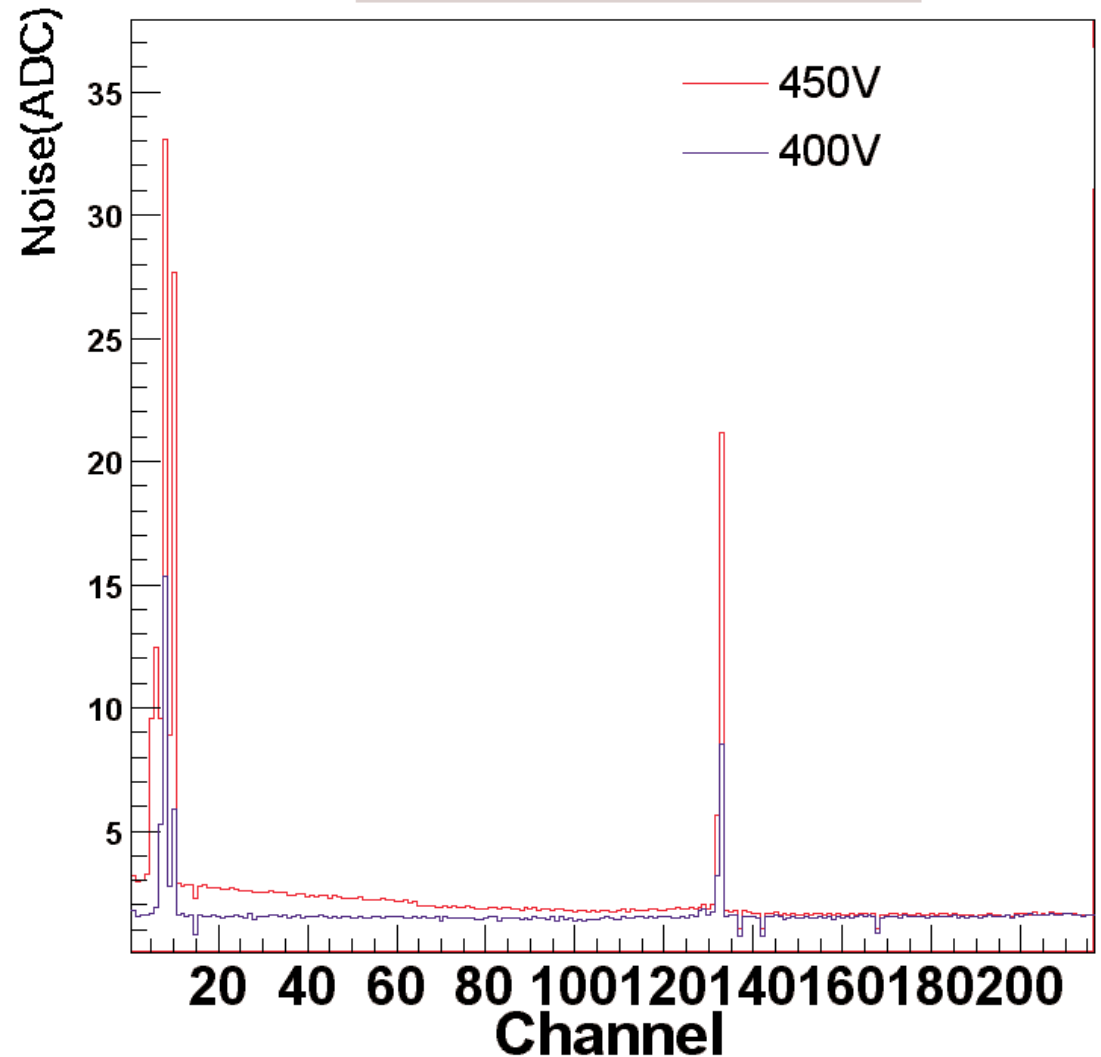
Module 1042

- Channels 7-10 show increased noise at 400 V.
- At 450V, chip 1 begins to show common mode noise
