US Production Report

CMS Tracker Steering Committee
4 September 2003

J. Incandela
University of California
Santa Barbara

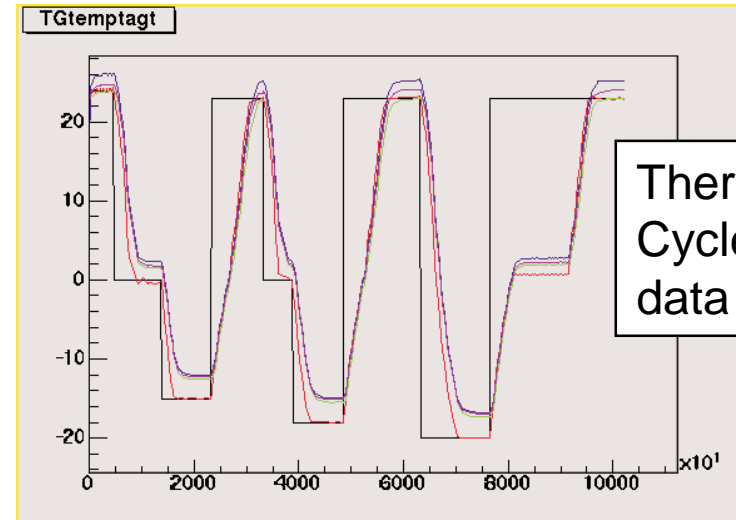
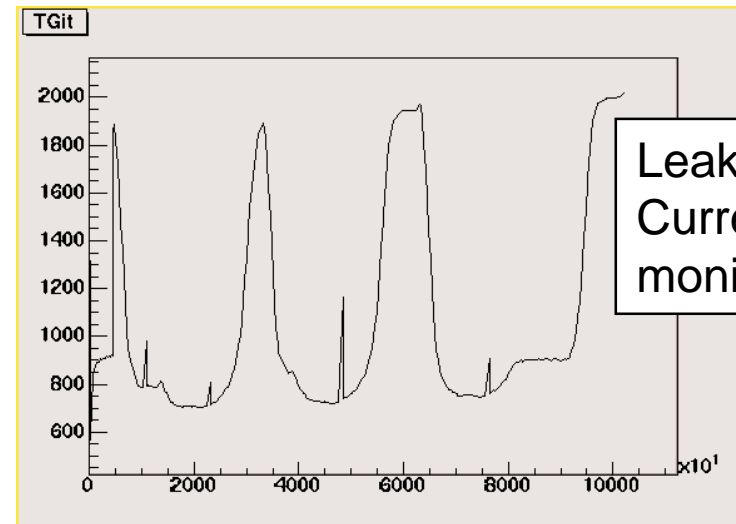
LT Test Results (UCSB)

- 21 modules had a weekday run of
 - 21 hours at 400 V
 - 3 cycles from 23C to -20C
- Subset of 4 modules had a weekend run of
 - 63 hours at 400 V
 - 9 cycles from 23C to -20C
- Subset of 5 modules had a weekend run of
 - 80 hours at 400V
 - 9 cycles from 23C to -20C
- Subset of 1 module had a weekday run + a weekend run of
 - 100 hours at 400V
 - 12 cycles from 23C to -20C
- No new bad channels found
- One channel w/slight increase in noise
